80960HA/HD/HT

Specification Update

April 1998

Order Number: [272830-005](#)

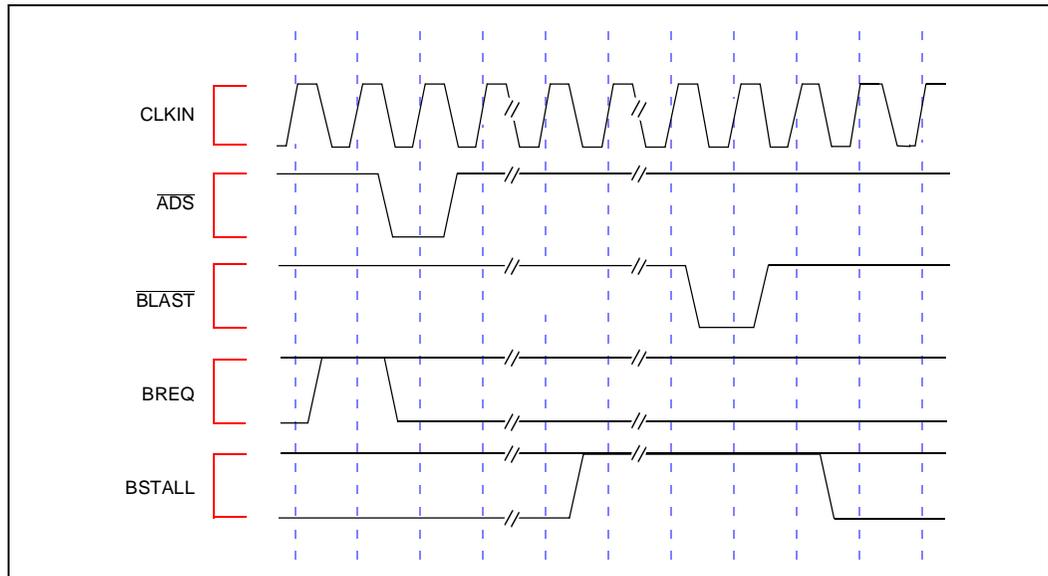
Figure 59. BREQ and BSTALL Operation

Implication: Bus arbitration logic that logically “ANDs” BSTALL and BREQ will not correctly grant the bus to the processor in all stall cases, potentially degrading processor performance.

Issue: The BSTALL signal does not always coincide with the BREQ signal. Logically “AND”-ing these two signals can cause an external bus arbiter to ignore a processor stall condition.

“If BSTALL is used for bus arbitration in an 80960Hx-ready system, the recommendation is to logically “OR” BSTALL and BREQ to indicate when the microprocessor requires the bus.”
