80960SA/SB SPECIFICATION UPDATE

Release Date: June, 1997
Order Number: 272850-002

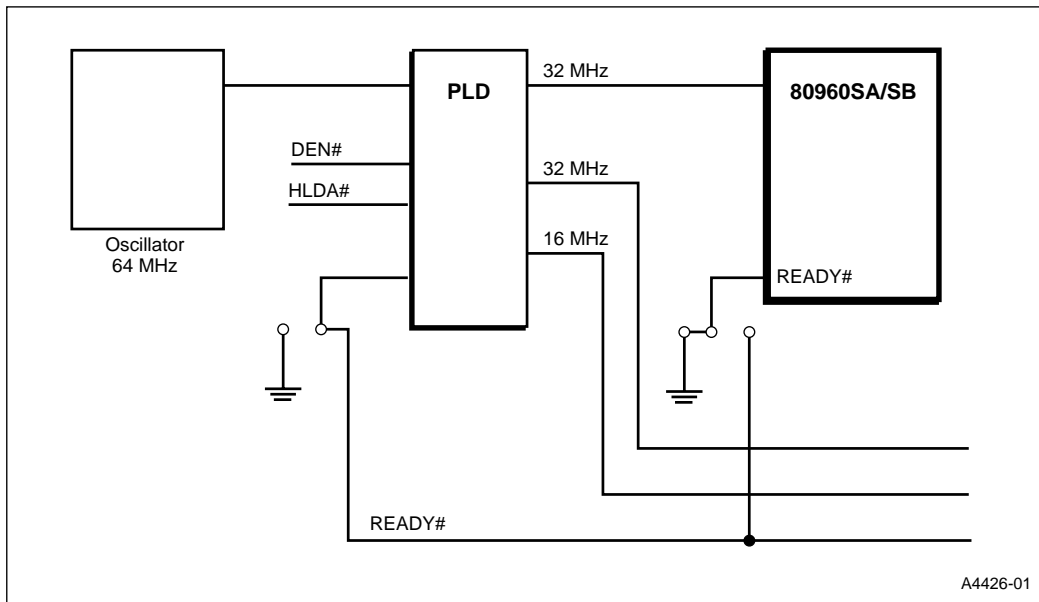
Figure 1. Block Diagram of Workaround

PROBLEM: During many accesses with wait states, the BE1:0# signals incorrectly switch after the first Tw state. The affected accesses include:

- All byte accesses with wait states.
- All quad-word, triple-word, long-word, word or short-word accesses with single-byte misalignment and wait states.

If the bus cycle is a burst access, the problem occurs on each data transfer within the burst. This problem will not occur if READY# always goes active early enough to signal zero wait states.

WORKAROUND: Do not use the READY# input; tie it to a LOW logic state. If wait states are necessary, gate the input clock using external logic.

Figure 1 illustrates example workaround logic. A programmable logic device (PLD) driven by a 4X clock oscillator provides a 2X clock for the 80960SA/SB and other system clocks. READY# is an input to the PLD which stops the 2X clock whenever it is asserted. When READY# is deasserted, the PLD resynchronizes the 2X clock to the system clocks. Figure 2 is a state diagram of the workaround.

The 80960SA/SB has dynamic registers, so do not stop its input clock for more than about one microsecond. This restriction limits the number of wait states to about nine for a 10 MHz 80960SA/SB.
