80960Jx Processor

Specification Update

December 1998

Order Number: 272852-006

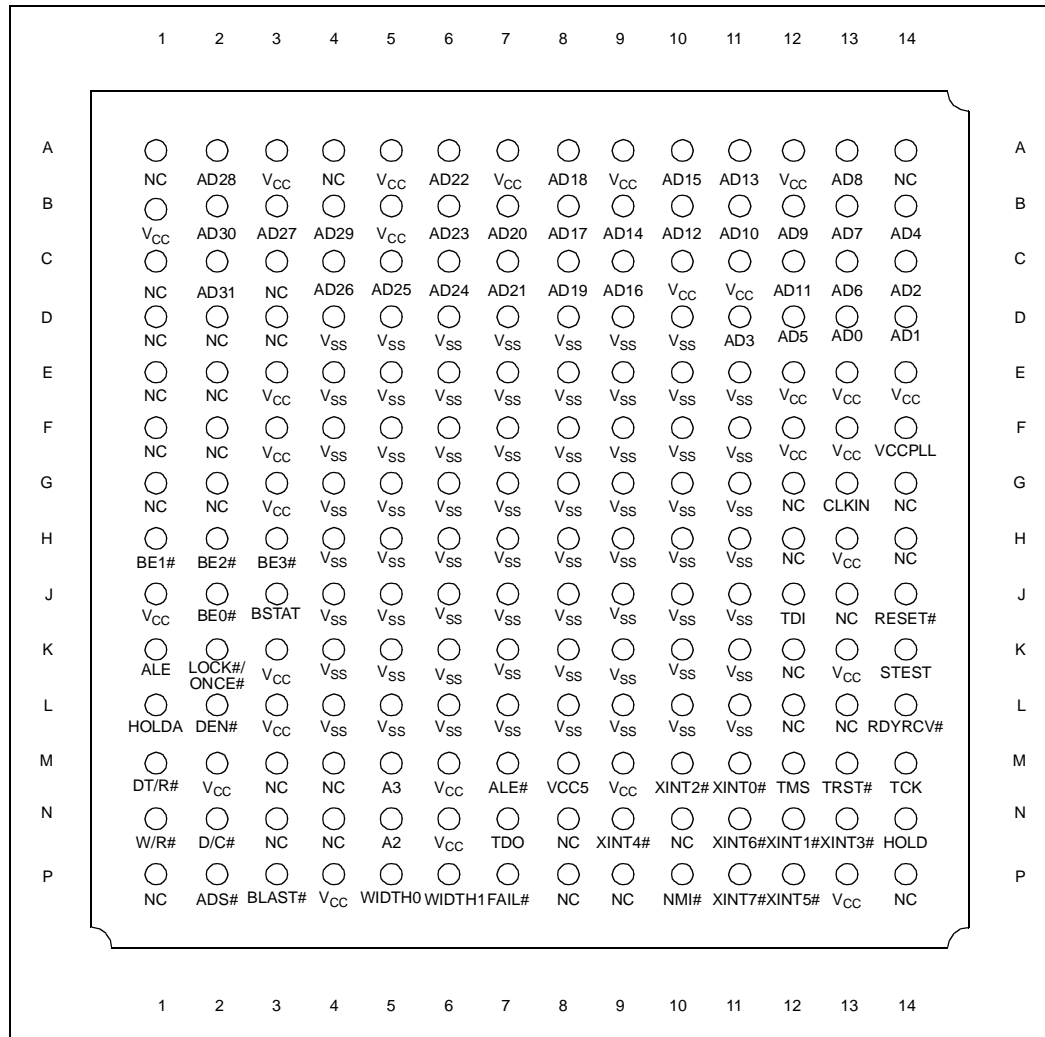
Figure 6. 196-Ball Mini Plastic Ball Grid Array Top View - Balls Facing Down

Figure 6 is the top view, “Balls Facing Down,” and should be oriented as shown:

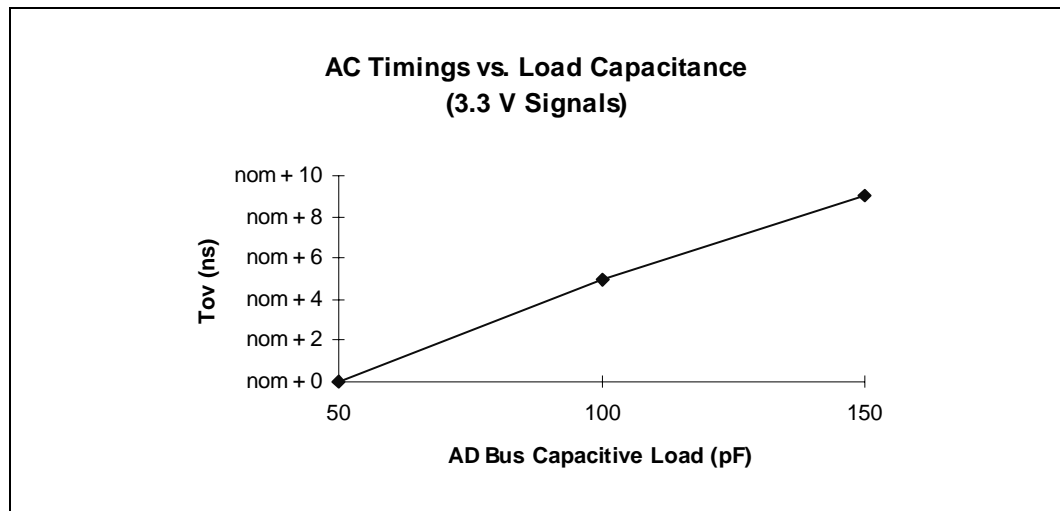
Output Delay or Hold vs. Load Capacitance (3.3 V Signals)

Problem: *80960JA/JF/JD/JT 3.3 V Microprocessor* datasheet, the “Output Delay vs. Load Capacitance” diagram and the “TLX vs. AD Bus Load Capacitance” diagrams do not apply to the 80960JT microprocessor (they are correct, however, for the JA/JF/JD microprocessors). The following diagrams and related notes provide the correct derating curve information for the 80960JT microprocessor:

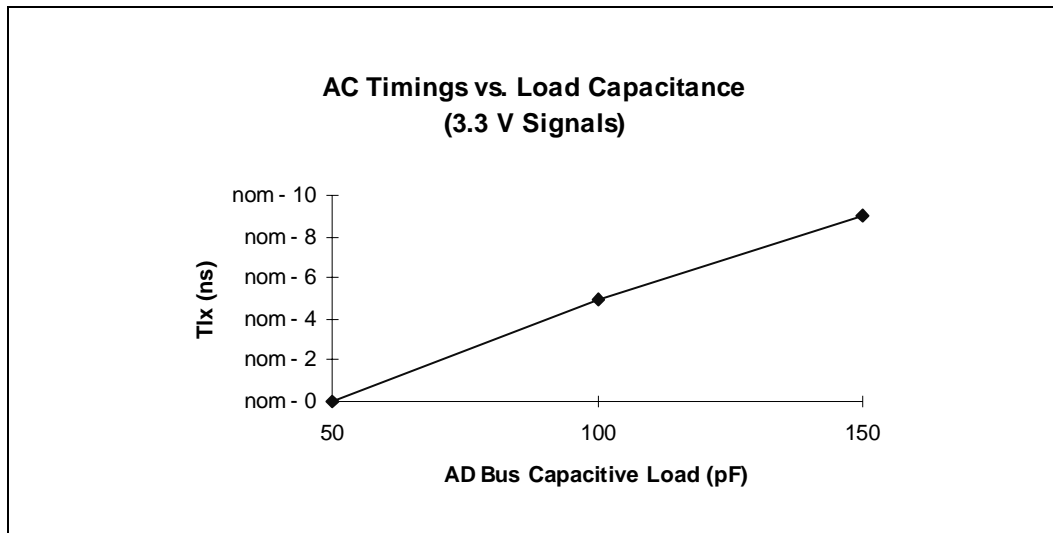
T_{LX} vs. AD Bus Load Capacitance (3.3 V Signals)

Note: The T_{LX} Derating curve applies only when an imbalance in the capacitive load occurs between the AD bus and ALE. The T_{LX} derating is based on a 50 pF load on ALE. The derating applies to ALE and ALE#.

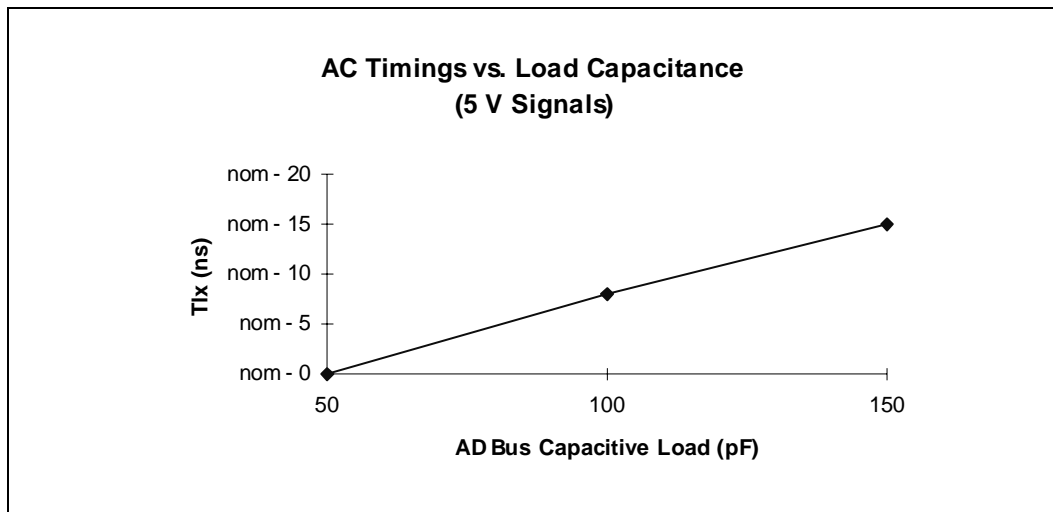
T_{LX} vs. AD Bus Load Capacitance (5 V Signals)

Note: The T_{LX} Derating curve applies only when an imbalance in the capacitive load occurs between the AD bus and ALE. The T_{LX} derating is based on a 50 pF load on ALE. The derating applies to ALE and ALE#.
