# **i960<sup>®</sup> RP/RD I/O PROCESSOR SPECIFICATION UPDATE**

Release Date: June, 1998  
Order Number: 272918-019

The i960<sup>®</sup> RP/RD I/O Processor may contain design defects or errors known as errata which may cause the product to deviate from published specifications. Current characterized errata are documented in this Specification Update.

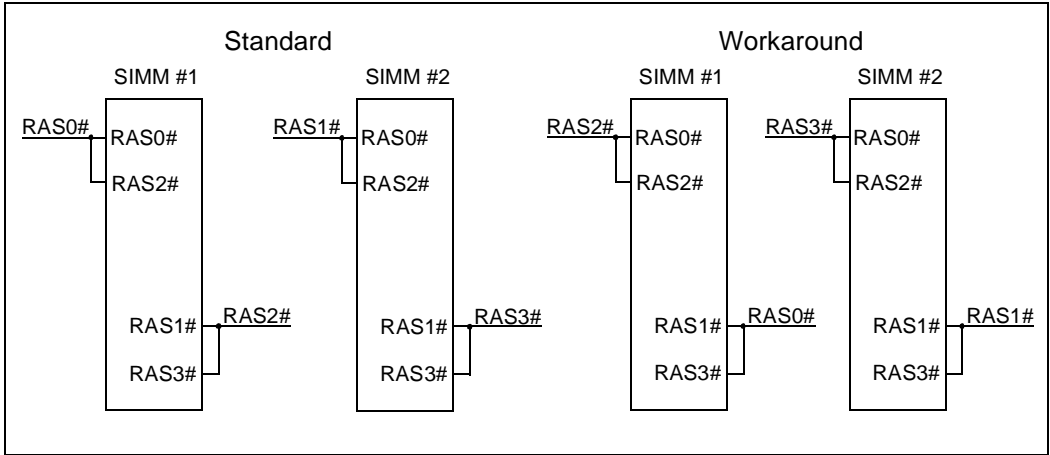
**Figure 1. DRAM RAS# Configurations**

**PROBLEM:** The 80960RP/RD MCU supports from one to four banks of DRAM. When the memory subsystem contains fewer than the maximum number of banks used in the 80960RP/RD design, certain addresses may cause the MCU to assert a RAS# to an empty bank. **Table 1** shows the relationship between the 80960 local memory address and the RAS# asserted by the MCU.

In a standard DRAM configuration, RAS0# and RAS1# are routed to the front sides of the SIMMs, and RAS2# and RAS3# are routed to the back sides of the SIMMs. To implement this workaround, swap RAS0# and RAS2# and swap RAS1# and RAS3#. This routes RAS2# and RAS3# to the front sides of their respective SIMMs, and routes RAS0# and RAS1# to the back sides of their respective SIMMs (See [Figure 1](#)). To determine which RAS# is asserted for a particular address and DRAM configuration, see [Table 1](#).

#### ***CASE 2 WORKAROUND - Initializing from 80960RP/RD DRAM instead of FLASH/ROM***

In an application using 4 Mbytes per bank/leaf and two single-sided SIMMs populated in a four bank design (total DRAM = 8 Mbytes), the following registers are set:

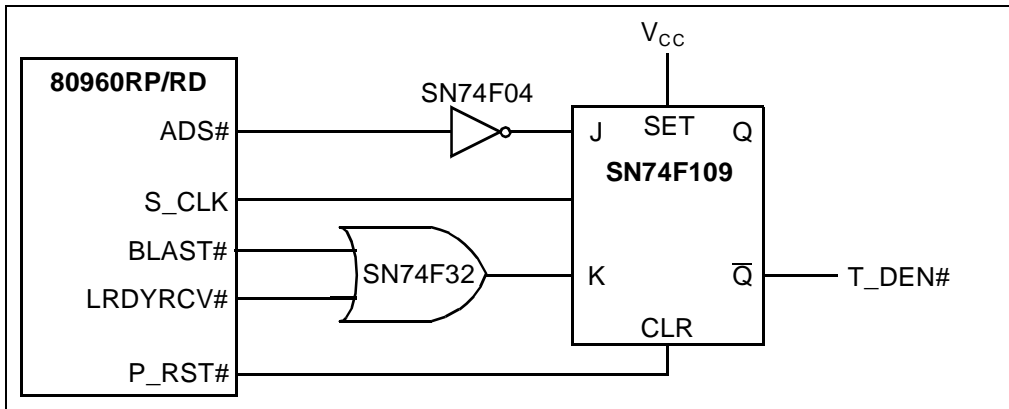
**ITEM:** When using an ICE in your 80960RP/RD system, the use of the Data Enable signal (DEN#) is not recommended. This clarification describes how DEN# operates and a recommended solution for using it with an In-Circuit Emulator (ICE).

**Using DEN# with an In-Circuit Emulator:** For ICE users, it is not recommended that you use the 80960RP/RD's DEN# signal directly to your transceivers. When executing an ICE microcode transaction, the expected behavior is that DEN# would remain de-asserted during the entire transaction. However, DEN# asserts as described above. If your design uses DEN# to enable transceivers, the transceivers will be enabled. This may result in bus contention.

**WORKAROUND:** To use an ICE with your 80960RP/RD design, alternatives to DEN# are:

- Ground the OE# pin of the transceiver
- Re-create a DEN# signal with the circuit shown below

The circuit asserts T\_DEN# (Q#) at the start of the first data cycle when ADS# asserts and BLAST# and LRDYRCV# de-asserts. T\_DEN# deasserts at the end of the last data cycle when ADS# de-asserts and BLAST# and LRDYRCV# assert. During RESET, T\_DEN# de-asserts.

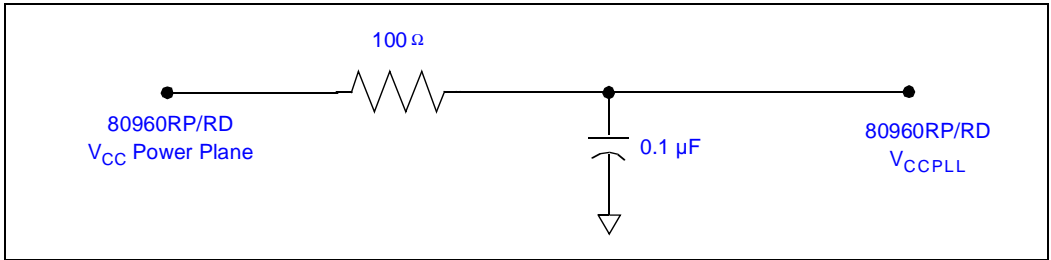
**Figure 11-6. V<sub>CCPLL</sub> Lowpass Filter**

**5. Section 11.7.4, Page 11-27, Figure 11-6**

Replace Figure 11-6 with the following figure:

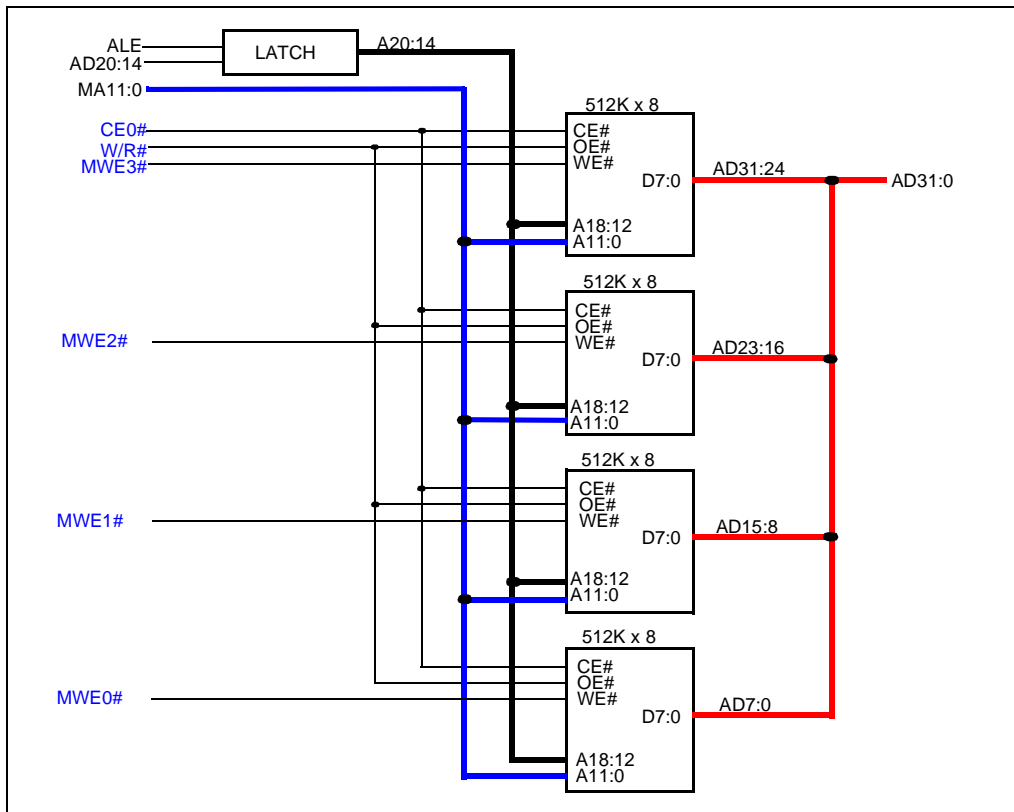
Figure 14-3. 32-Bit ROM or SRAM System

Figure 14-3 is incorrect. The correct figure is shown below:
