Intel386™ DX PROCESSOR SPECIFICATION UPDATE

Release Date: August, 2004
Order Number: 272874-003

The Intel386™ DX processor may contain design defects or errors known as errata. Characterized errata that may cause the Intel386 DX processor's behavior to deviate from published specifications are documented in this specification update.

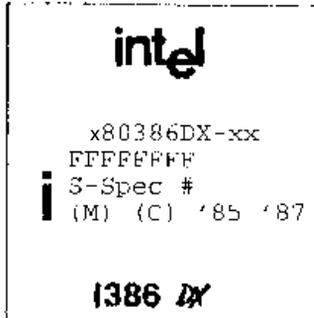
Intel386™ DX CPU-F0 (CHMOS IV)

The F0 part is identified with the following marks:

Intel386 DX processors may be identified electrically according to device type and stepping. Refer to the data sheet for instructions on how to obtain the identifier number.
